concrete façade restoration project

Mission National Bank San Francisco, California

Restoring sand-blasted and weathered decorative concrete elements with an extremely vapor permeable façade protection system against water infiltration without fading or peeling for 30 years.

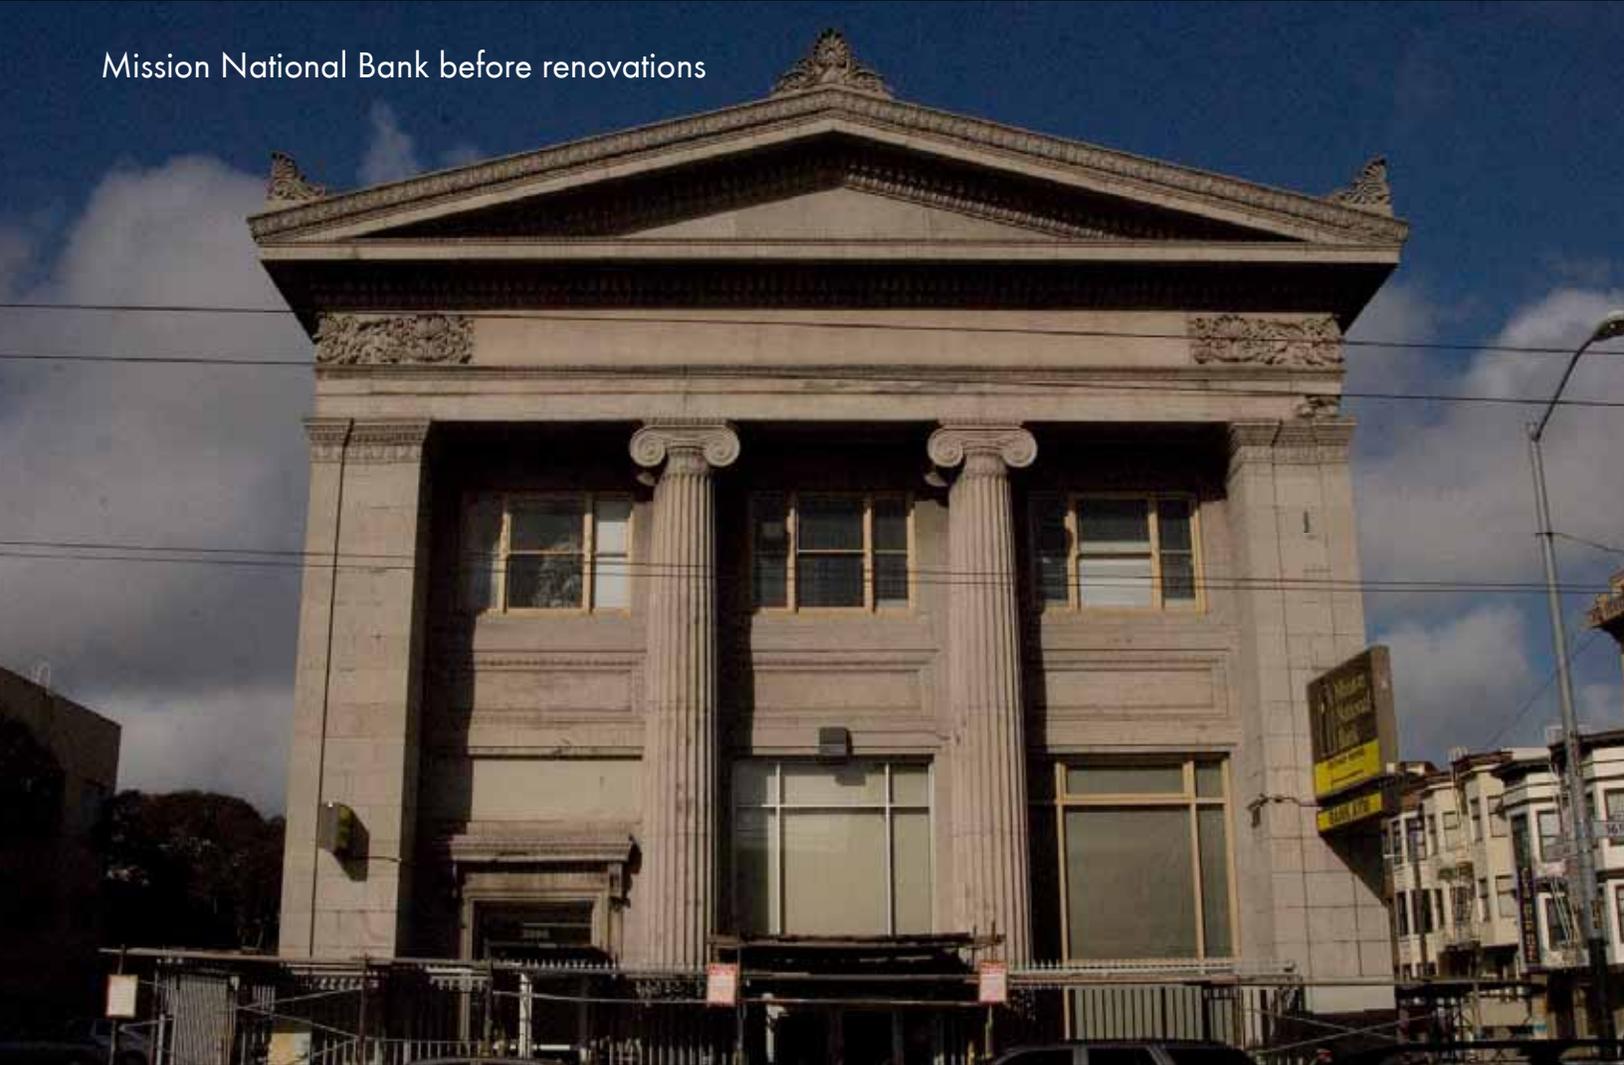
Mission National Bank before renovations

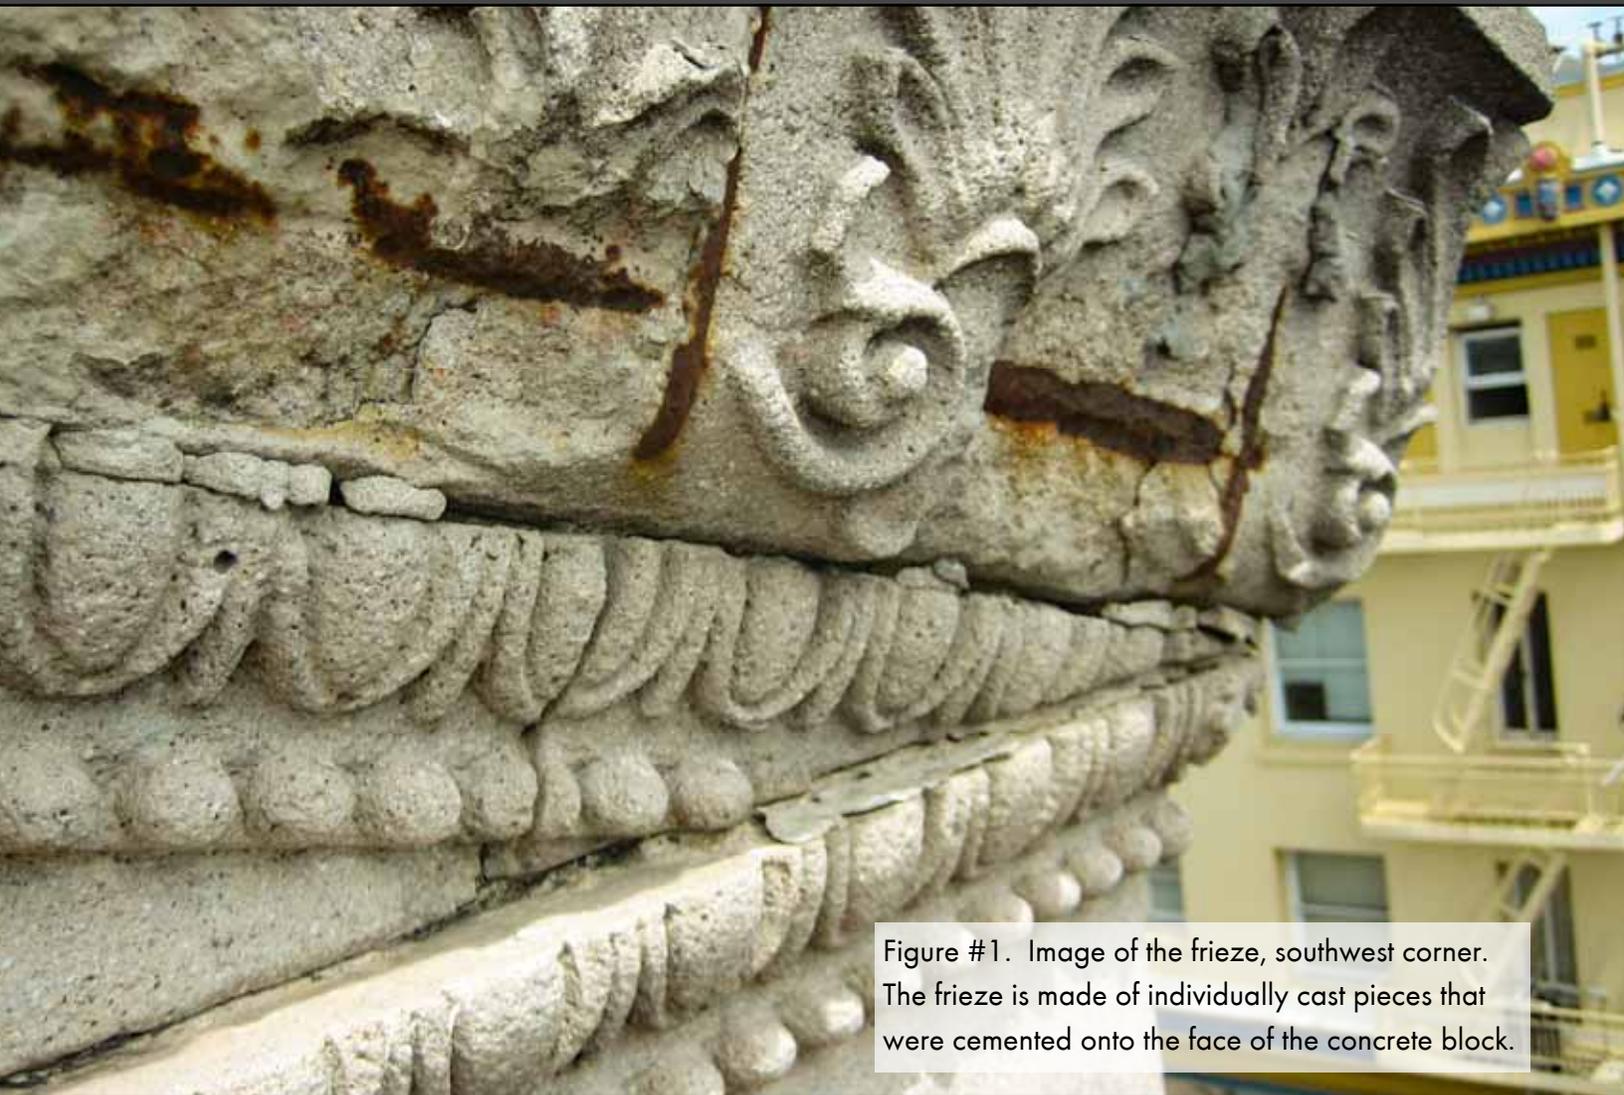
Figure #1. Image of the frieze, southwest corner. The frieze is made of individually cast pieces that were cemented onto the face of the concrete block.

The cast pieces were reinforced with steel rebar that was placed too close to the surface. When the protective outer skin of the cast concrete was removed, carbon dioxide was able to move deep within the concrete carbonating the protective alkaline passivation layer surrounding the steel reinforcement. The opened pores allowed rain water to be drawn into the concrete carrying oxygen that corroded the unprotected steel, thus expanding its size. This is the force that fractured the concrete's structure causing ultimate failure.

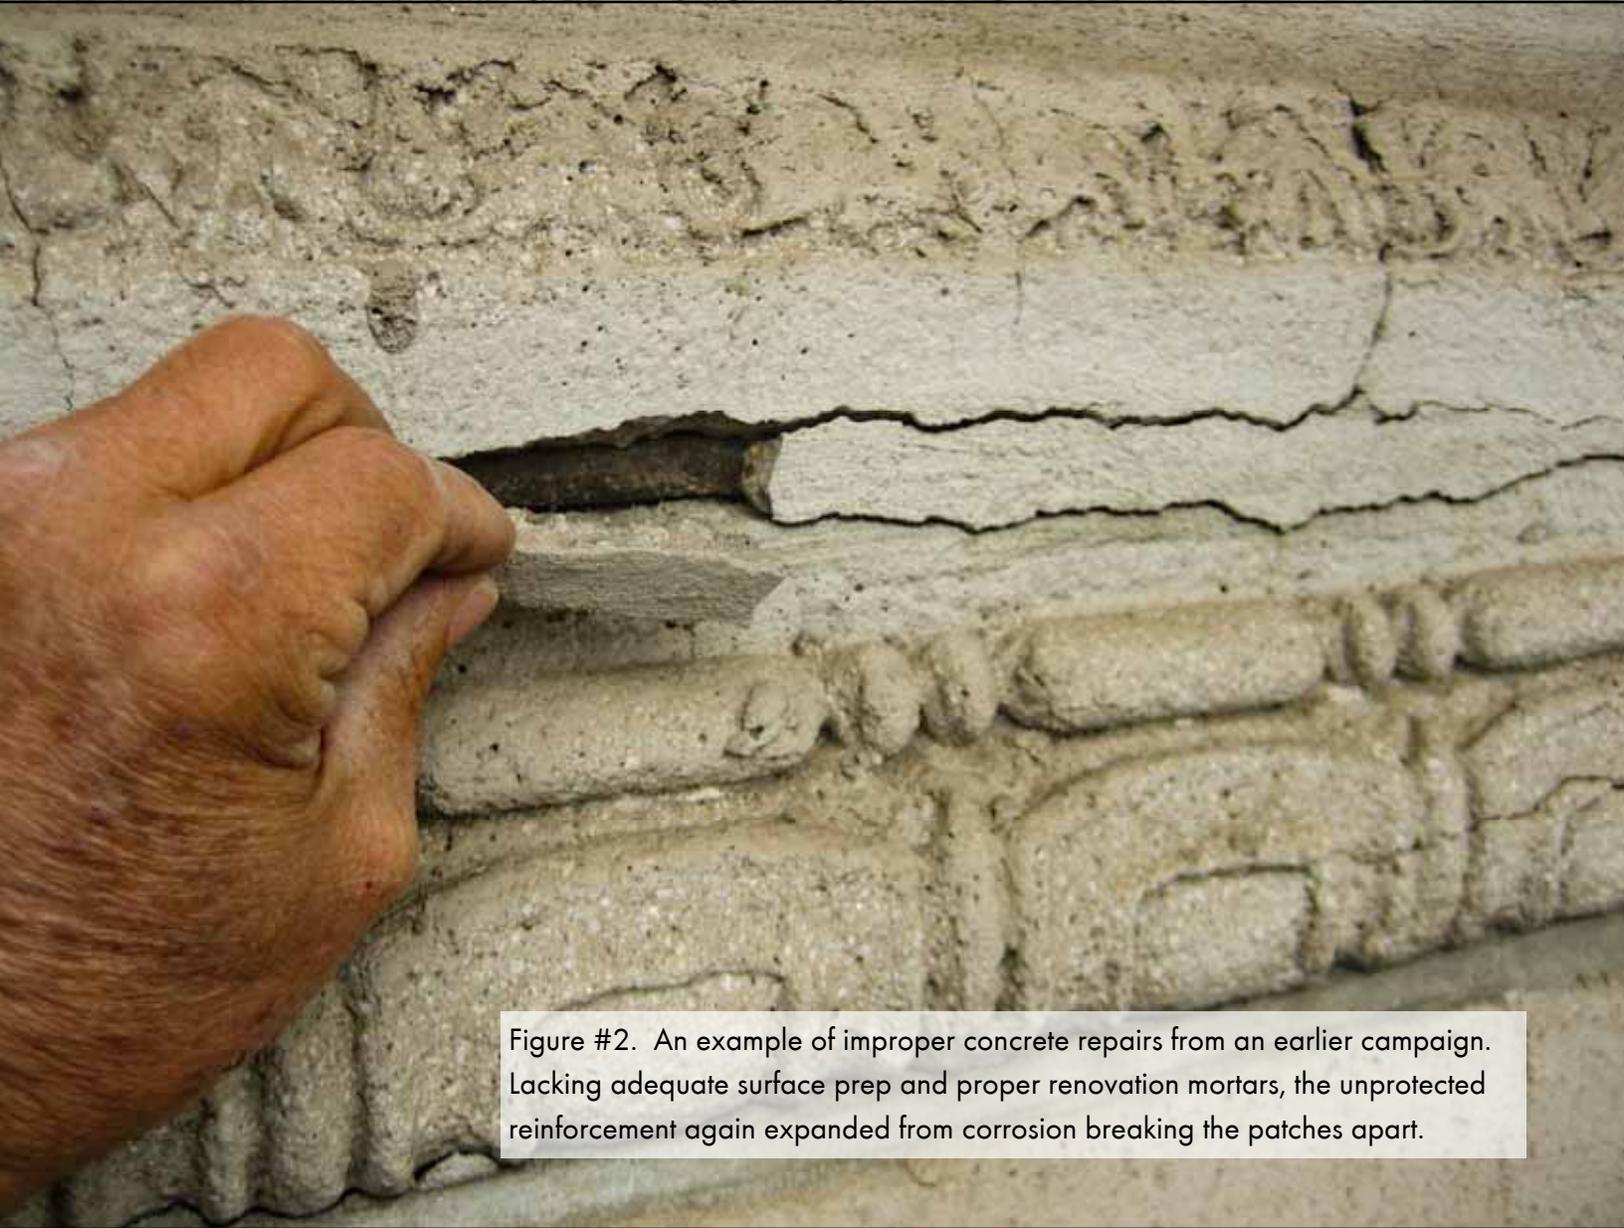
Figure #2. An example of improper concrete repairs from an earlier campaign. Lacking adequate surface prep and proper renovation mortars, the unprotected reinforcement again expanded from corrosion breaking the patches apart.

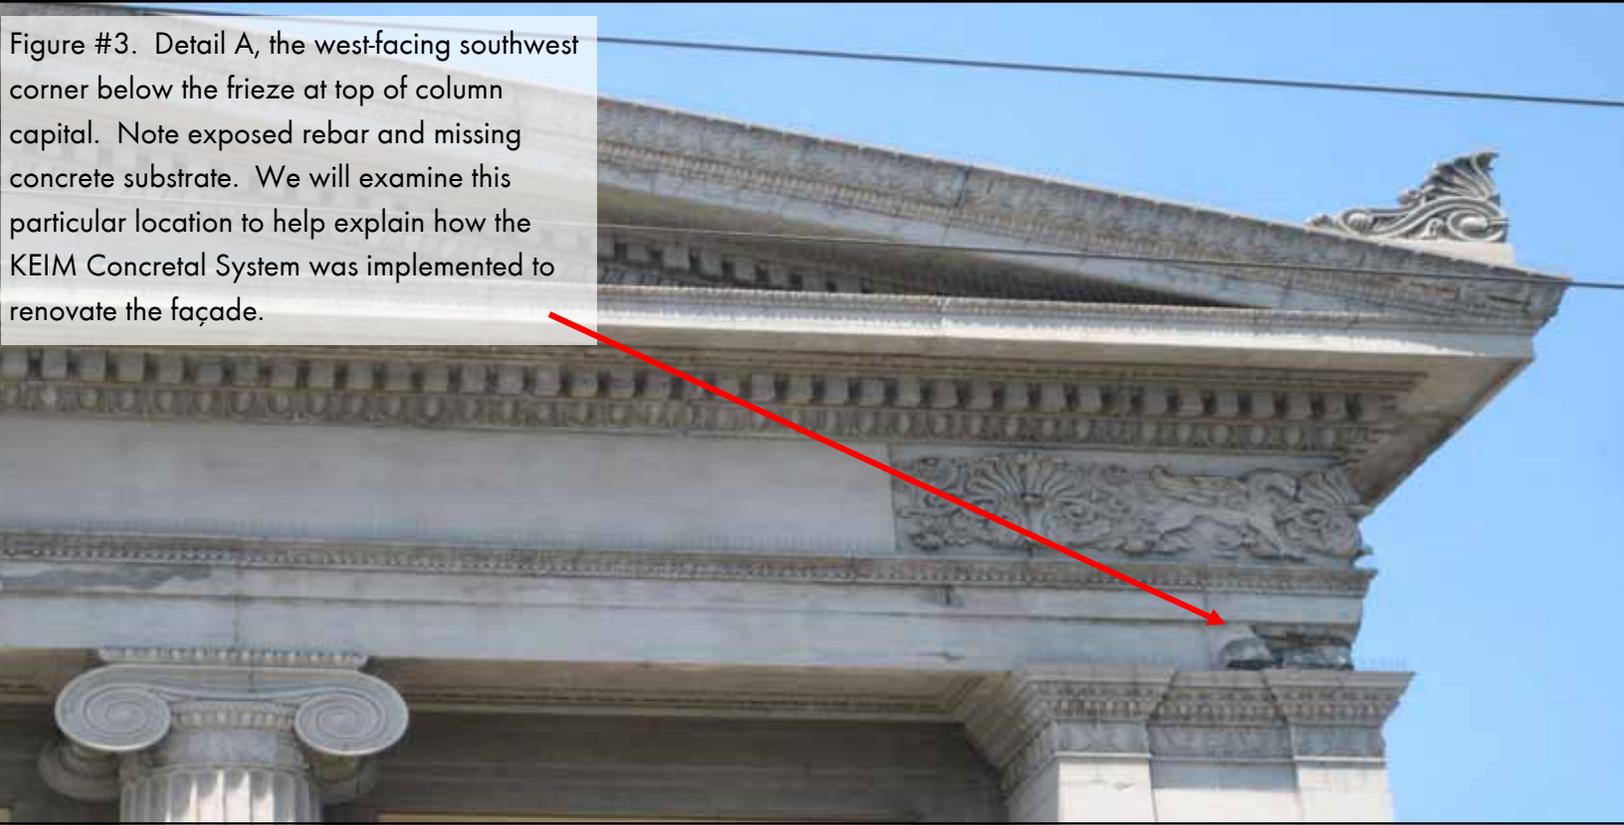
Figure #3. Detail A, the west-facing southwest corner below the frieze at top of column capital. Note exposed rebar and missing concrete substrate. We will examine this particular location to help explain how the KEIM Concretal System was implemented to renovate the façade.

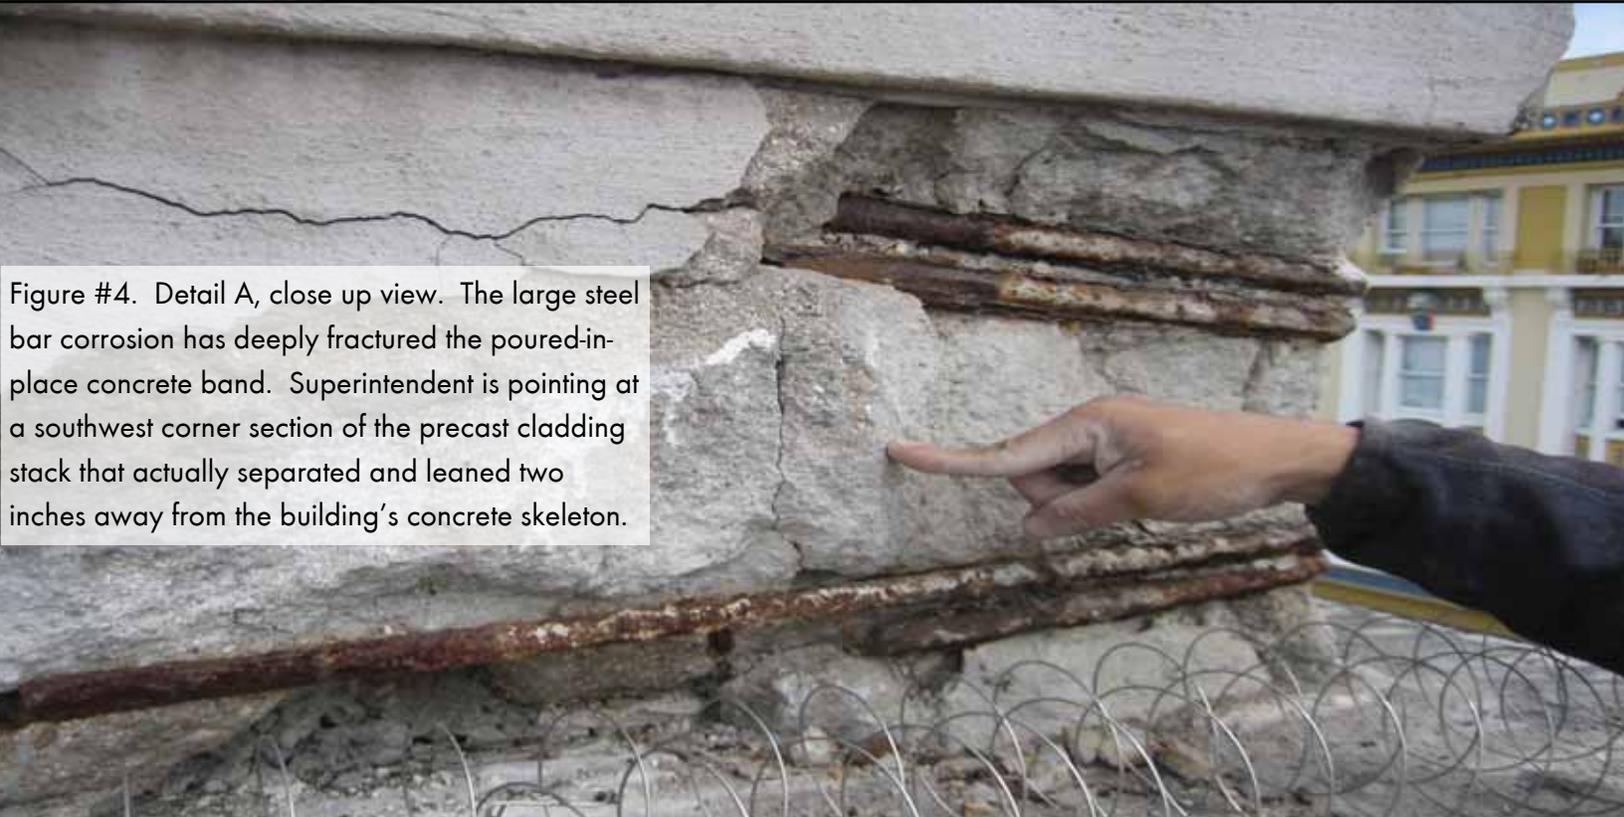
Figure #4. Detail A, close up view. The large steel bar corrosion has deeply fractured the poured-in-place concrete band. Superintendent is pointing at a southwest corner section of the precast cladding stack that actually separated and leaned two inches away from the building's concrete skeleton.

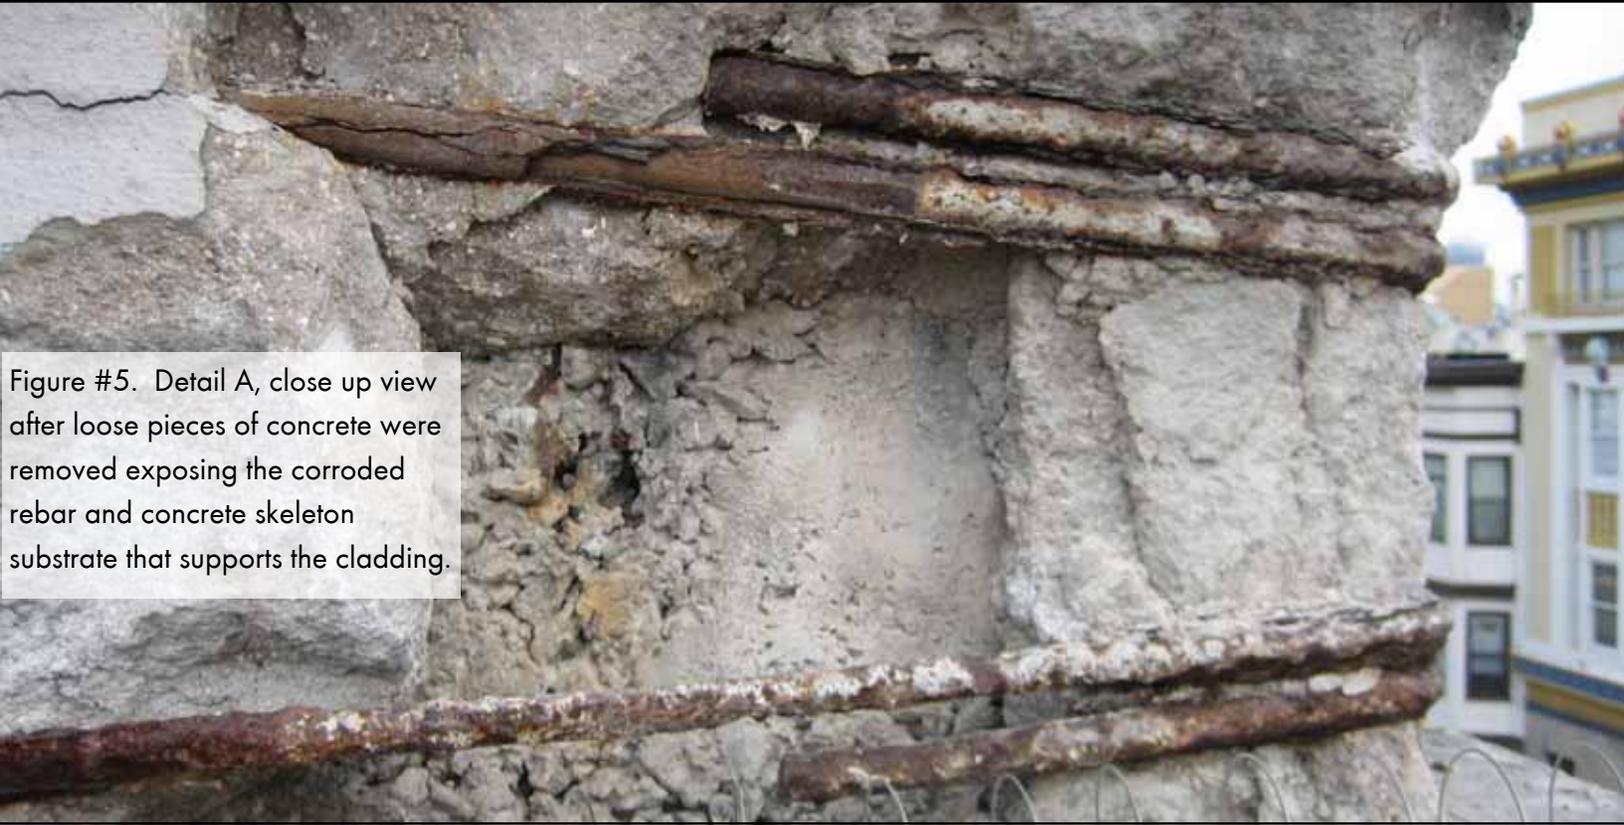
Figure #5. Detail A, close up view after loose pieces of concrete were removed exposing the corroded rebar and concrete skeleton substrate that supports the cladding.

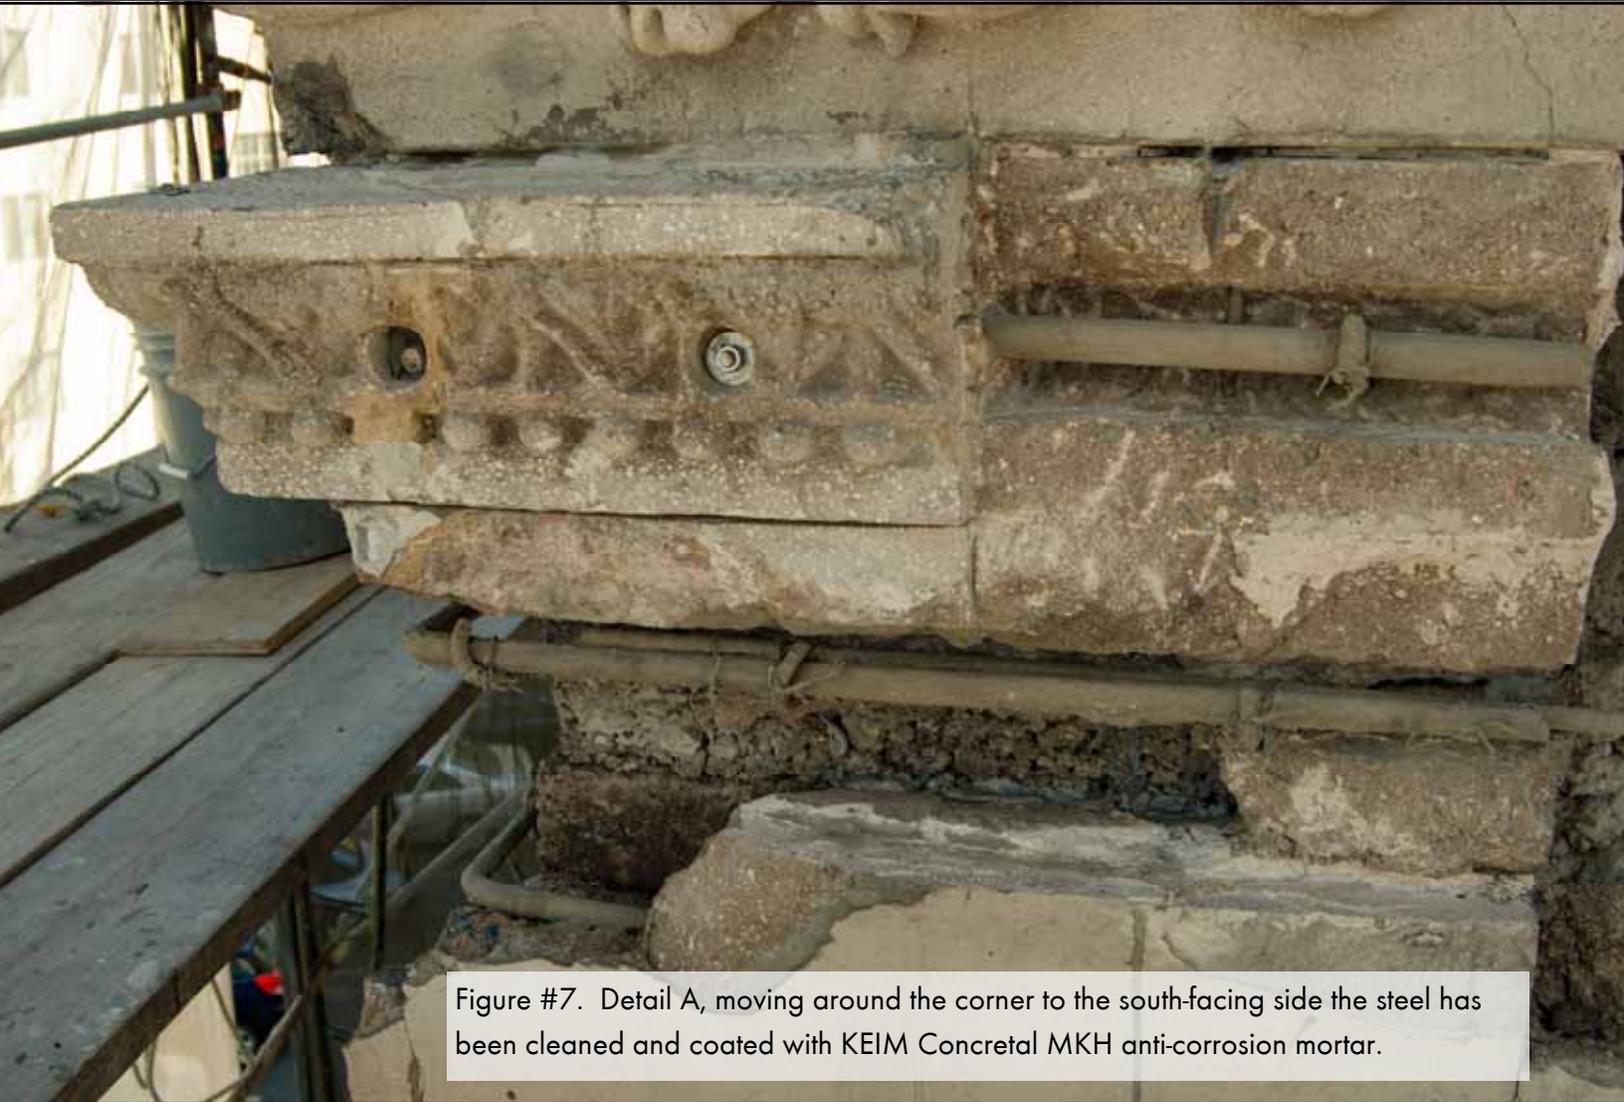
Figure #7. Detail A, moving around the corner to the south-facing side the steel has been cleaned and coated with KEIM Concretal MKH anti-corrosion mortar.

The next step was to dampen the surfaces and substrate with water, allow the water to soak in, apply a bridge coat of Concretal MKH by brush immediately followed with the placement of KEIM Concretal Mortar R to fill the voids.

Surfaces were retextured to match original and replacement decorative pieces were cast from molds made from intact decorative elements using reinforcement steel and KEIM Concretal Universal Mortar S and cemented in place with Concretal Universal Mortar S.

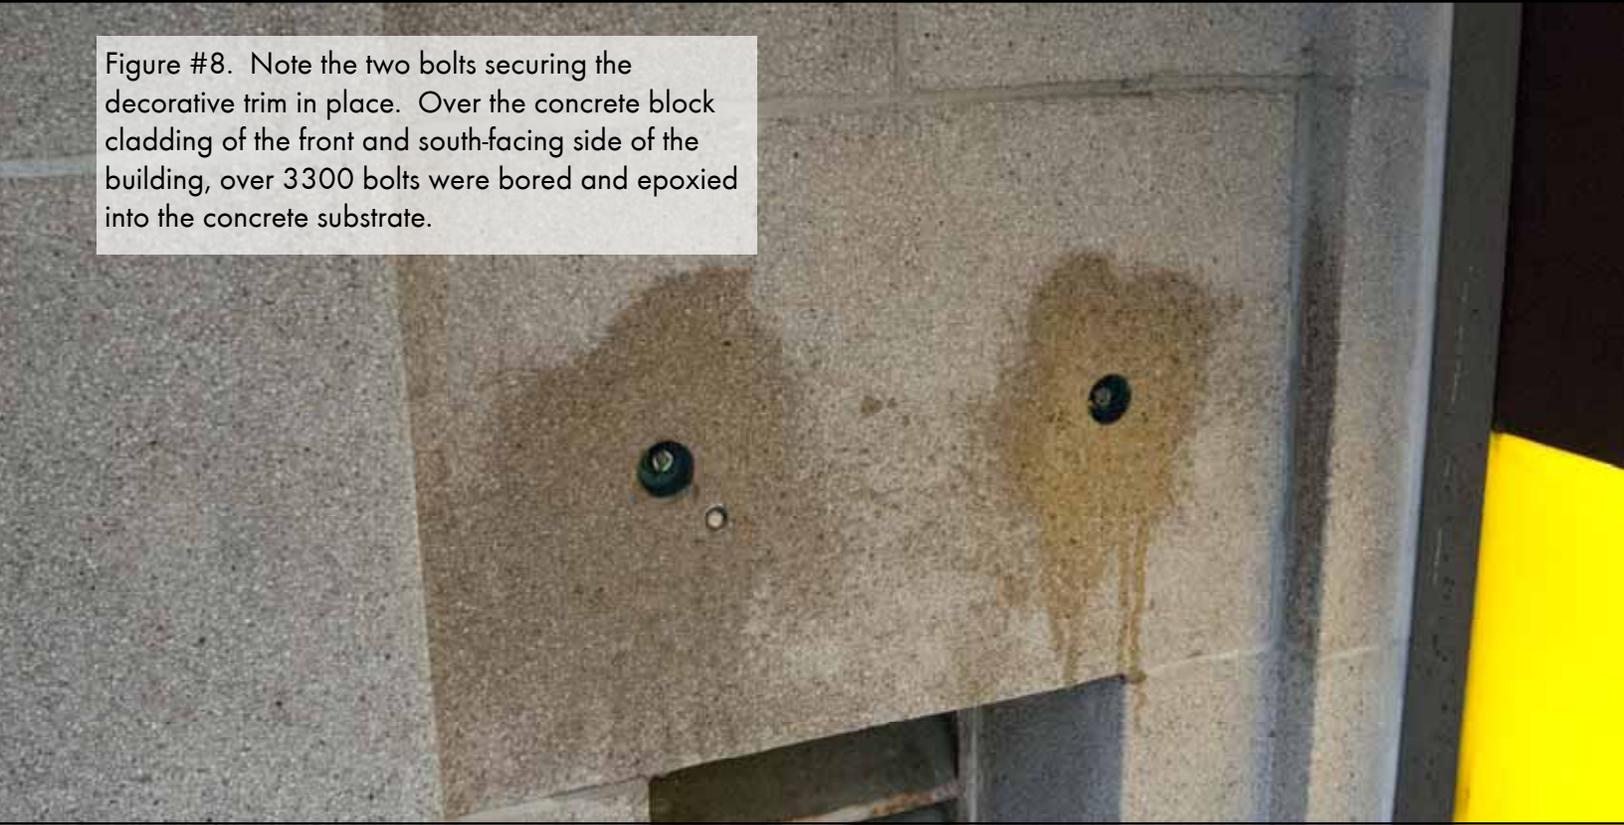
Figure #8. Note the two bolts securing the decorative trim in place. Over the concrete block cladding of the front and south-facing side of the building, over 3300 bolts were bored and epoxied into the concrete substrate.

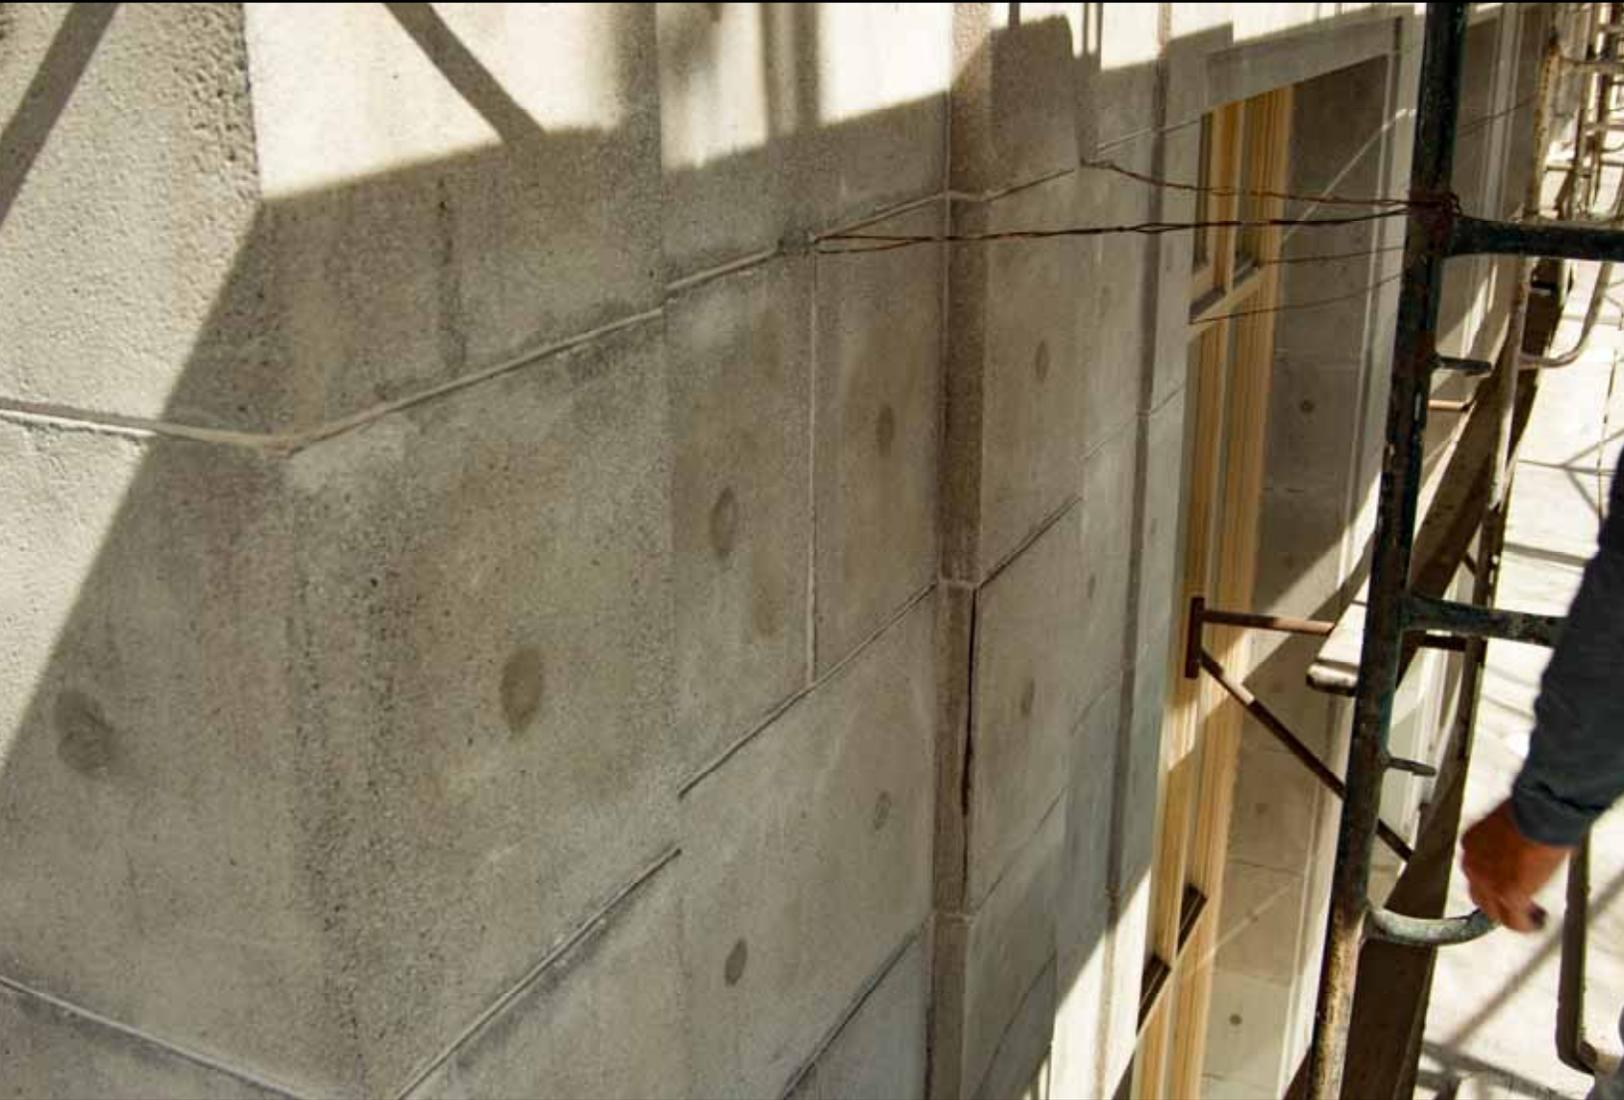
Figure #10, above. Image of the precast cladding with the filled bolt head cavities.

Normally this is a serious aesthetic issue that is difficult to overcome with ordinary finishes and silicate coatings. KEIM recommends a coarse-grained silicate base coat called "Grob" that blends the textures of these patched holes and other concrete repairs with the surrounding surfaces to homogenize the appearance of the façade.

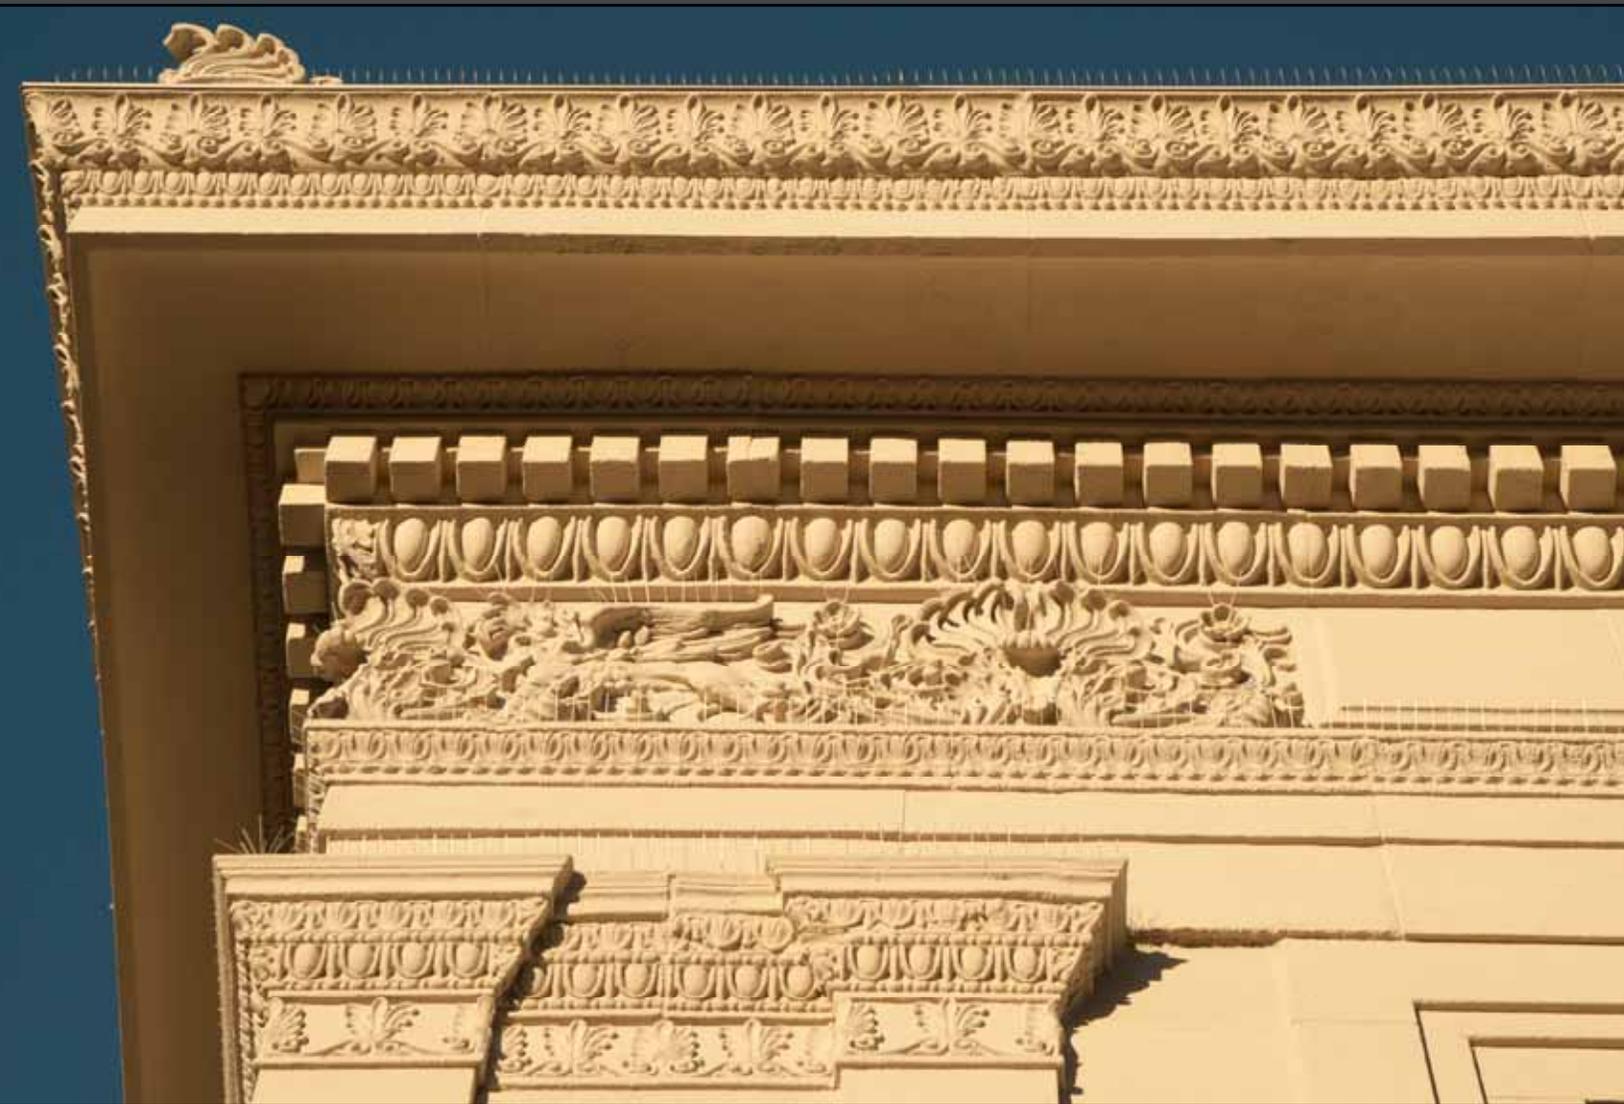
Figure #11, above. Finished southwest corner of the building.

Fine details are retained even after three coats of KEIM Concretal W silicate coating. KEIM silicate coatings chemically bond to the concrete and cement forming permanent bonds. The natural beauty of KEIM coatings spreads light across surfaces with soft luminosity. Concrete elements retain their concrete appearance, not lost to the coating which is so often the case with non-mineral high performance paints and coatings.

Image taken at 9 AM as the sun was rising above the surrounding buildings. Note the color is influenced by the warmth of the sunrise as the building's actual color is light gray.

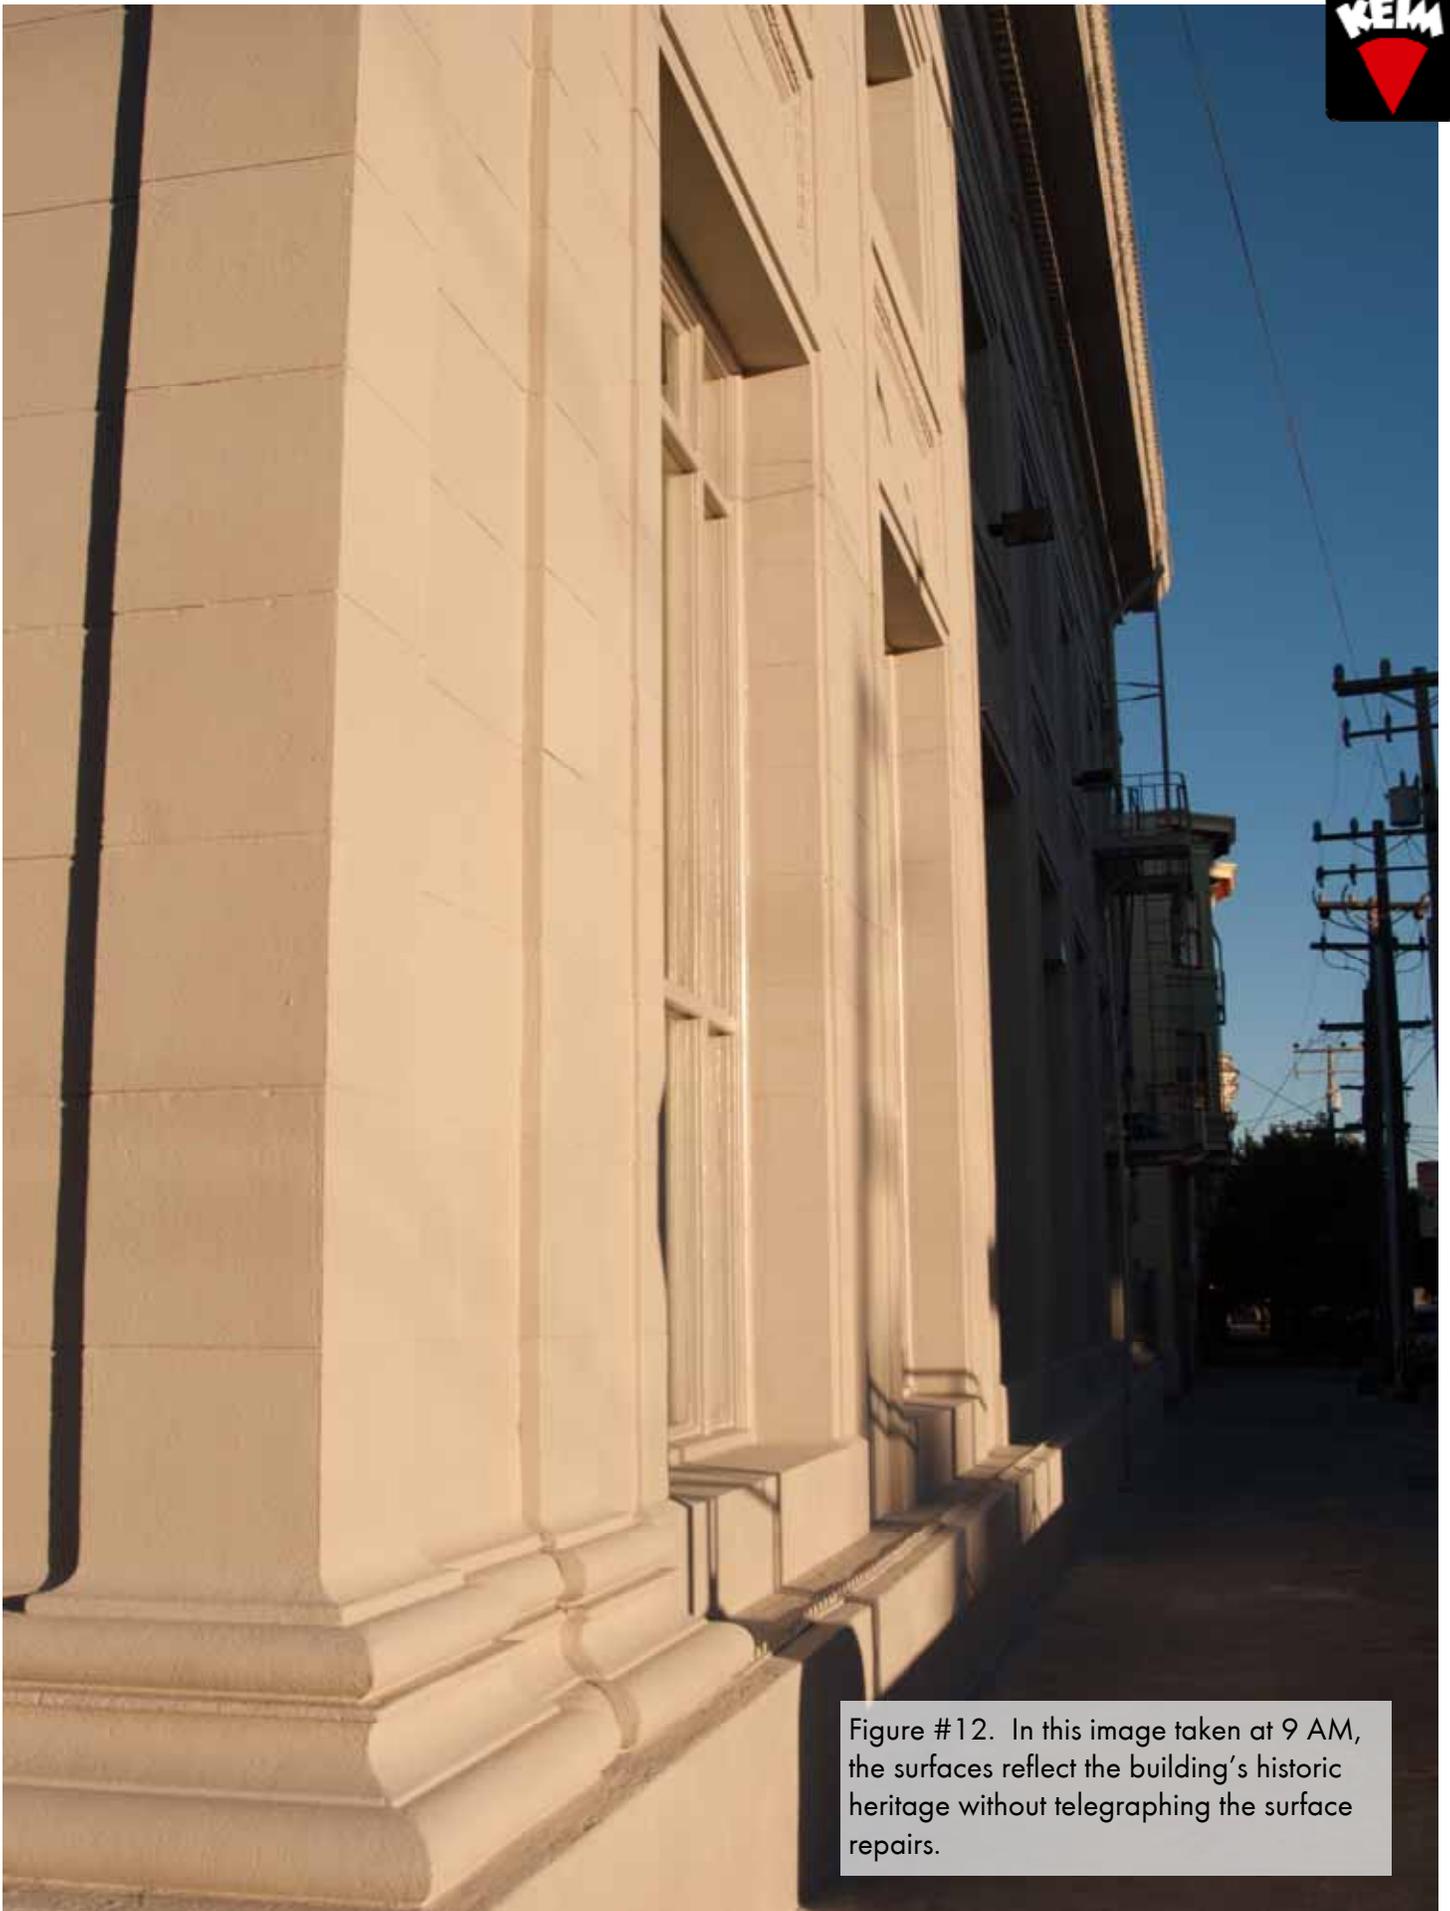
Figure #12. In this image taken at 9 AM, the surfaces reflect the building's historic heritage without telegraphing the surface repairs.

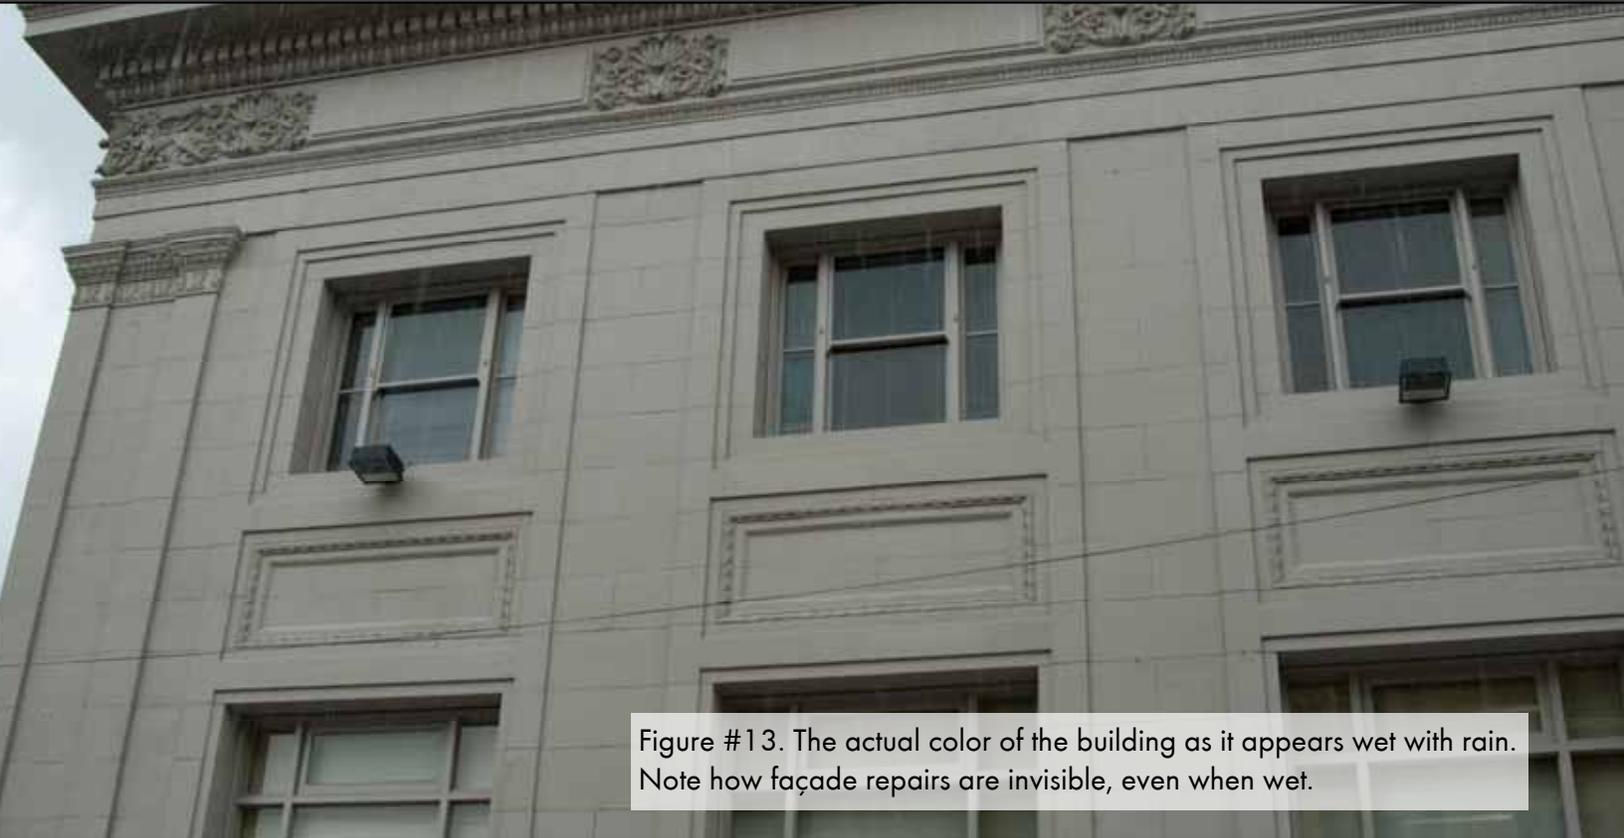
Figure #13. The actual color of the building as it appears wet with rain. Note how façade repairs are invisible, even when wet.
